Home Inspection Report

Northern New York Home Inspections
857 State Route 122
Constable, NY 12926

Report Overview

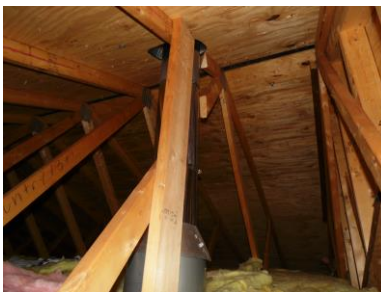
- **Monitor:** Truss members shall not be cut, notched, drilled, spliced or otherwise altered in any way without the approval of a registered design professional. This area should be evaluated by the manufactures roof truss engineer and prescribe repairs to be done by a qualified contractor.

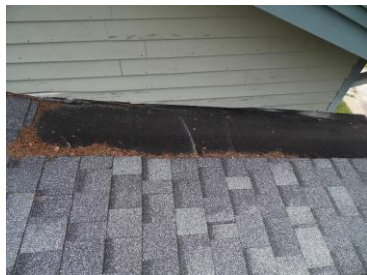
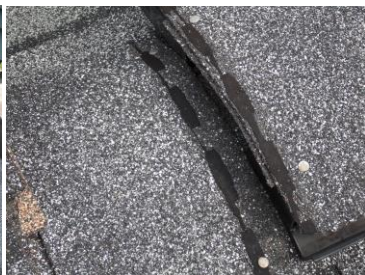
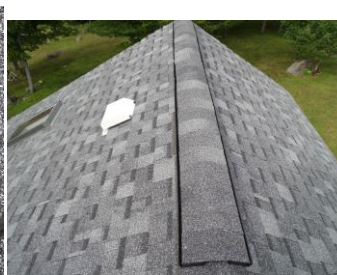
- **Repair:** It is recommended that gutters and downspouts be installed to avoid spilling roof runoff around the building – a potential source of water entry or water damage.
- **Repair:** Minor repairs to the roofing are needed. Damaged or missing roofing material should be repaired. All roof penetrations should be examined and sealed as necessary.

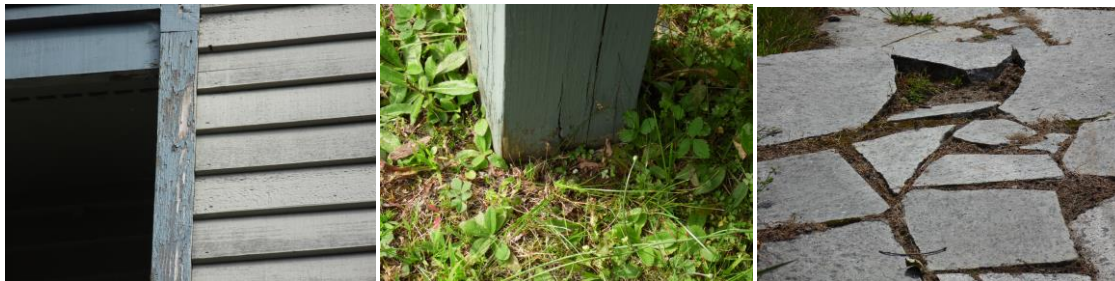
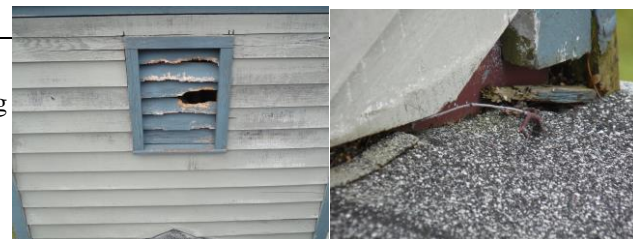
- **Repair:** The wood siding should be painted to preserve the building.
- **Repair:** It is recommended that the damaged siding be replaced.
- **Repair:** Damage to the vent is suspected to be the result of vermin activity. Repairs are needed. Depending on the nature of the vermin activity, consulting an animal control specialist may be desirable.

- **Repair:** The garage door opener is inoperative. It should be repaired as necessary.
- **Monitor:** The garage floor slab has typical cracks usually the result of shrinkage and/or settling of the slab. Cracks more than 1/8" high could present a trip hazard.

- **Repair, Safety Issue:** The openings in the porch railing are large enough to allow a child to fall through. It is recommended that this be altered for improved safety.

- **Repair, Safety Issue:** As there is a danger of falling, a railing should be provided on the walkway leading to the driveway.
- **Repair, Safety Issue:** The walkway presents a trip hazard. This condition should be altered for improved safety.

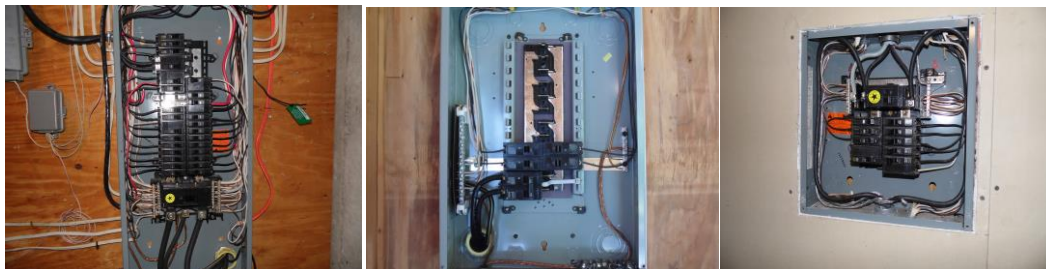
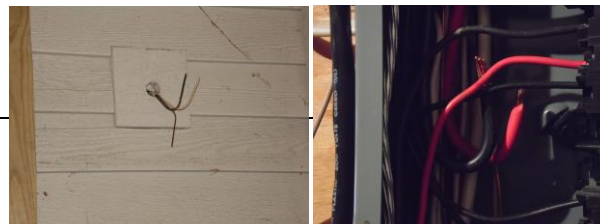
- **Safety Issue:** Any openings in the main panel should be covered.
- **Repair:** Abandoned wiring should be removed or appropriately terminated with a box and cover.
- **Safety Issue:** All junction boxes should be fitted with cover plates, in order to protect the wire connections.
- **Repair:** Improper electrical connections should be repaired. All electrical connections should be made inside junction boxes fitted with cover plates.
- **Repair:** Missing outlet cover plates should be replaced to avoid a shock hazard.
- **Safety Issue:** The installation of a ground fault circuit interrupter (GFCI) is recommended next to kitchen sink. A GFCI offers increased protection from shock or electrocution.

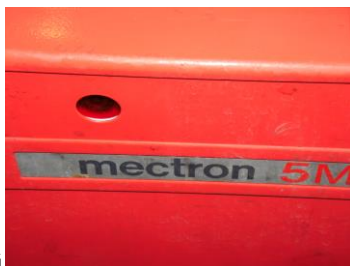
- **Monitor:** Old boilers tend to be less efficient than newer units. While replacement of the boiler would result in lower heating costs, replacement is often not cost justified if the present unit is reliable and if after cleaning and adjustment its efficiency is 74% or better.
