Home Inspection Report

Northern New York Home Inspections
857 State Route 122
Constable, NY 12926

Report Overview

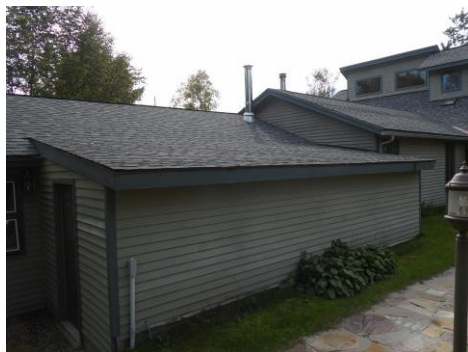
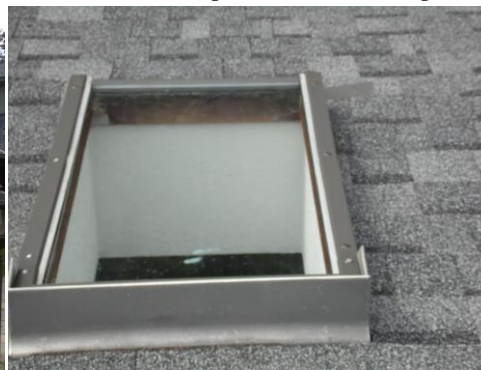
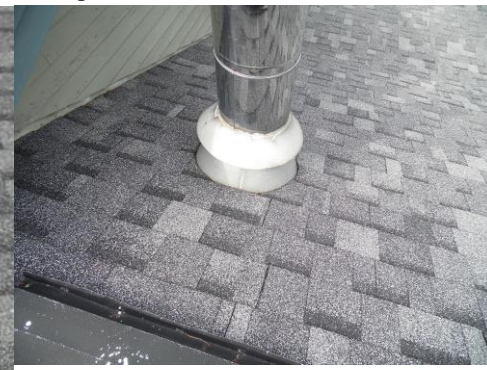
- **Repair:** It is recommended that gutters and downspouts be installed to avoid spilling roof runoff around the building – a potential source of water entry or water damage.
- **Repair:** Minor repairs to the roofing are needed. Damaged or missing roofing material should be repaired. All roof penetrations should be examined and sealed as necessary.
